## PIGGING IN THE ARCTIC CIRCLE

Anthony Lowery, Baker Hughes, UK  
Richard Sharvin, Baker Hughes, Netherlands

### Abstract

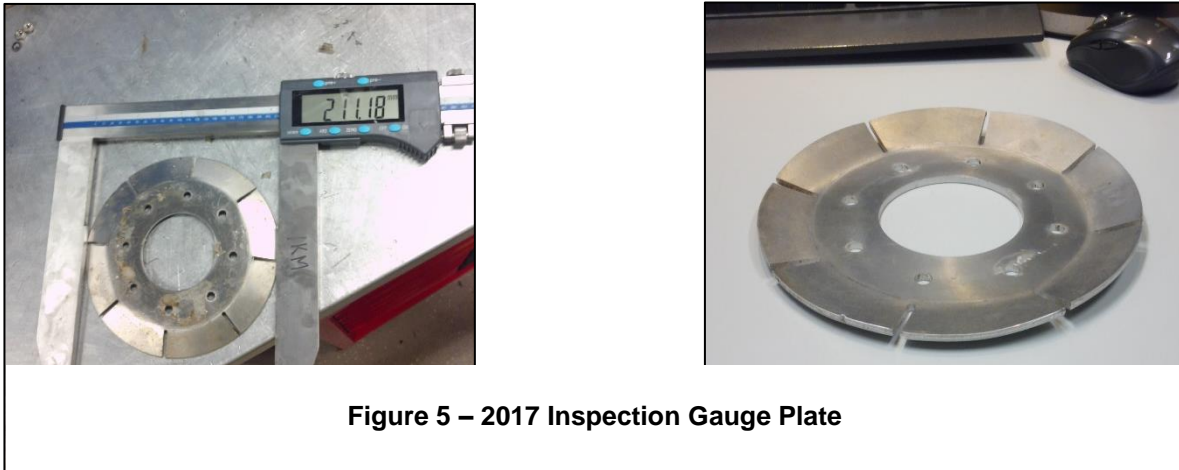
**Figure 5 – 2017 Inspection Gauge Plate**

Prior to running the inspection vehicle, IKM Testing ran a gauge pig to ensure that the bore of the pipeline was within the minimum bore passing capability of the inspection vehicle. Baker Hughes provided the gauge plate requirements which was a 215mm diameter aluminium gauge plate ~4mm thick and segmented to allow a clear indication of any local deflection. Upon receipt of the gauge pig, the plate was removed, and the minimum diameter measured and photographed. The minimum diameter was measured at 211.18mm, which was below the minimum local bore passing capability of the inspection vehicle. The operation was suspended and a meeting convened to discuss the potential causes and next steps.

The first task undertaken was a review of the piggable items list provided by IKM Testing to consider the internal diameters of each pipeline segment to determine where the damage may have occurred. At the meeting, Baker Hughes advised on the potential risks of progressing with an unknown bore restriction in the pipeline and a decision was taken to demobilise and consider further options to assess what may have caused the damage to the gauge plate.

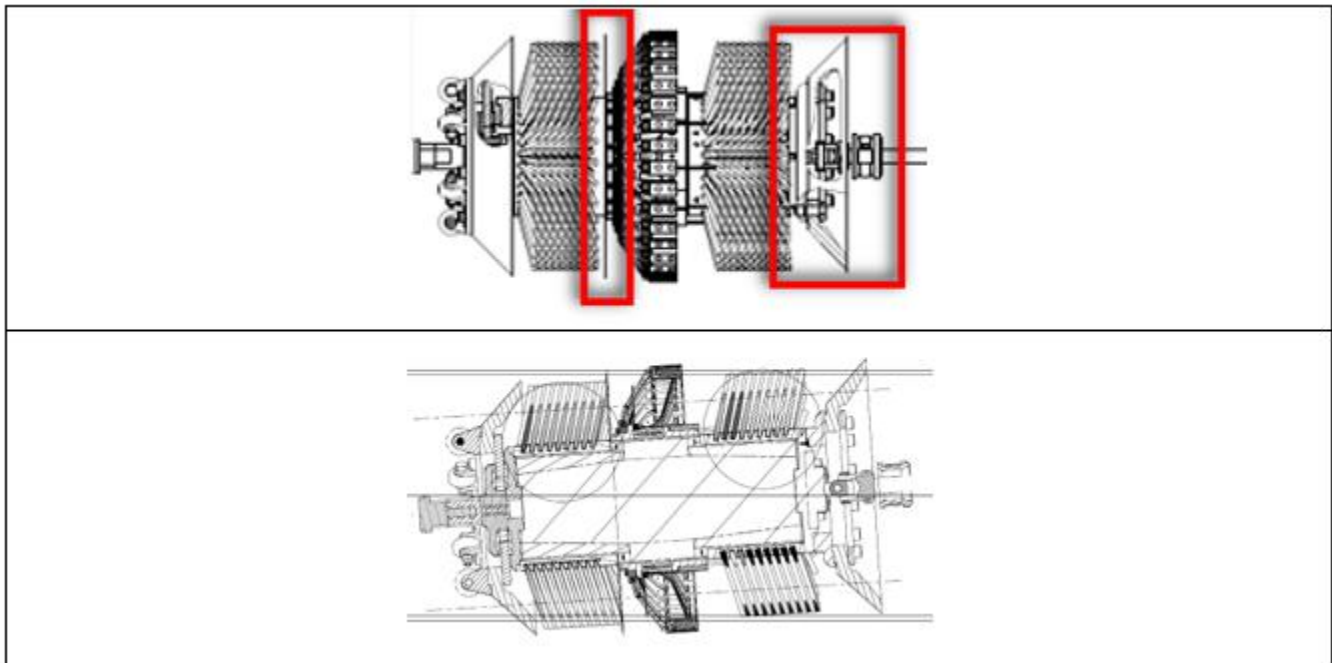
**Figure 8 - MFL secondary drive elements and position of MV in 263mm lead-in spool**

Once the inspection vehicle was fully pulled into the spool, it was noted that the MV nose was downward. This is primarily due to the direction of pull from the pull-in chain and lack of support from the reduced length bristles that form part of the 10" reduced bore passing kit. This concern was noted, and consideration given to review the front support of the inspection vehicle. To progress with the secondary testing, the nose was lifted and centred using a soft sling.

This testing proved essential given the findings and resulting actions. In the process of improving the passing capability of the MagneScan inspection vehicle, the support to the MV was compromised to the effect that in 263mm NB pipe the front cup was not sealing. If run in the pipeline in this build, the vehicle would have driven and passed the reduced bore sections albeit in a nose-down orientation in the nominal bore with reduced magnetisation from the lack of bristle contact and downward attitude. This would have affected the metal loss detection and sizing capability and also affected the mapping units' recorded data. As a result of these findings, the test was suspended.

There was some concern that, once the lead in spool was fitted to the pump-through rig during start-up of the pump, water would bypass the front drive cup and the vehicle would fail to drive and/or engage in the first section of the reduced bore pipe spool (205mm ID). Baker Hughes therefore fitted secondary drive elements (highlighted in red below) to ensure that the given flow equated to ~0.3m/s and the vehicle would drive into the reduced bore section.

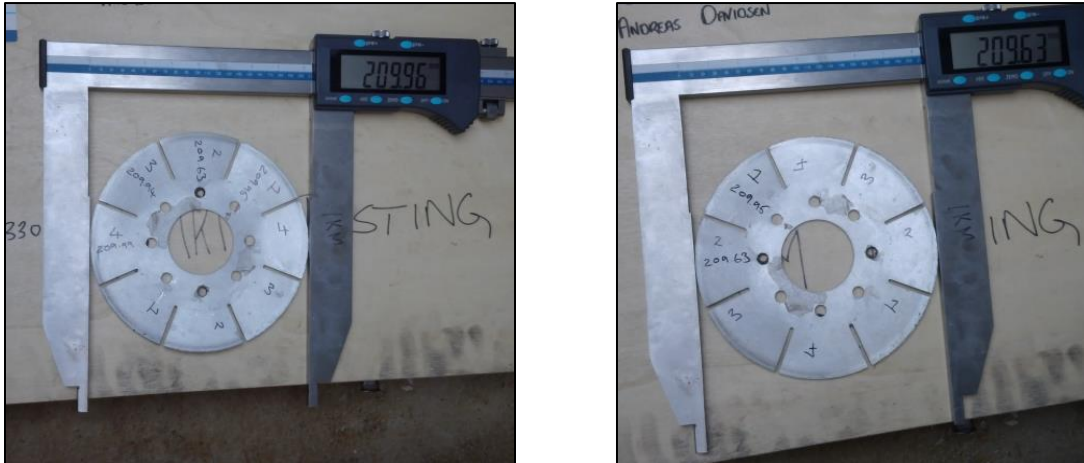
**Figure 11 - 2019 Inspection Gauge Plate**

As only a single segment on the gauge plate was deflected, it was determined with advice provided by Baker Hughes' Application Engineering department that this may have been as a result of impact in a bend or offtake and Baker Hughes could proceed with the MFL Inspection run.
