LONG DISTANCE INLINE INSPECTION OF AN UNPIGGABLE NATURAL GAS PIPELINE WITH ROBOTIC TECHNOLOGY

By: David Gian, Intero Integrity Services BV, Netherlands
and Rod Lee, Intero Integrity Services BV, Netherlands

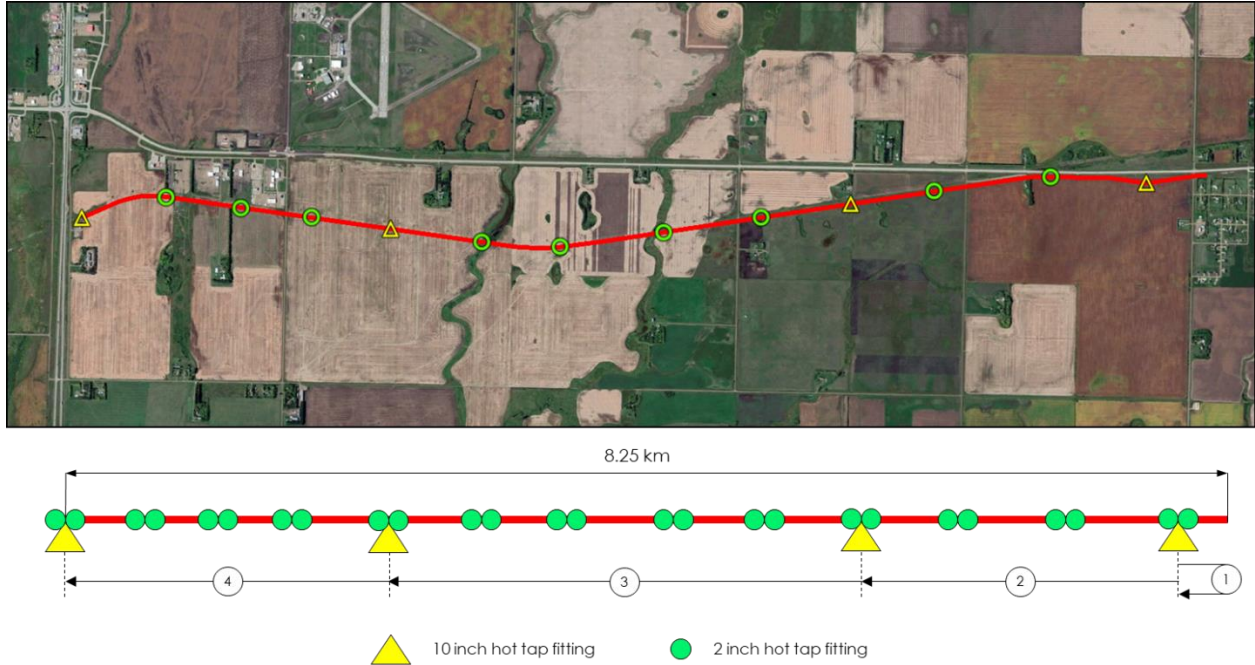
In order to address pipelines which do not have existing launchers and receivers the Pipe Explorer robots have been designed to launch through size-on-size hot tap fittings. In the case of the Brandon lateral, the pipeline operator installed four of these hot tap launch and receive sites over the entire length of the 8.3 km pipeline. Intero operators have the ability to either launch and receive from a single fitting (Out-and-Back) or launch at one site and receive at another (Point-to-Point) so, given the overall length of the line and the fittings that were installed on the pipeline, both methods would be utilized on the project. As outlined in Figure 4, Intero's Pipe Explorer 10/14 was launched and received at the same location one time at the east end of the pipeline and the remainder of the inspection was completed by travelling from launch site to launch site.

Figure 4: Schematic of Brandon Lateral

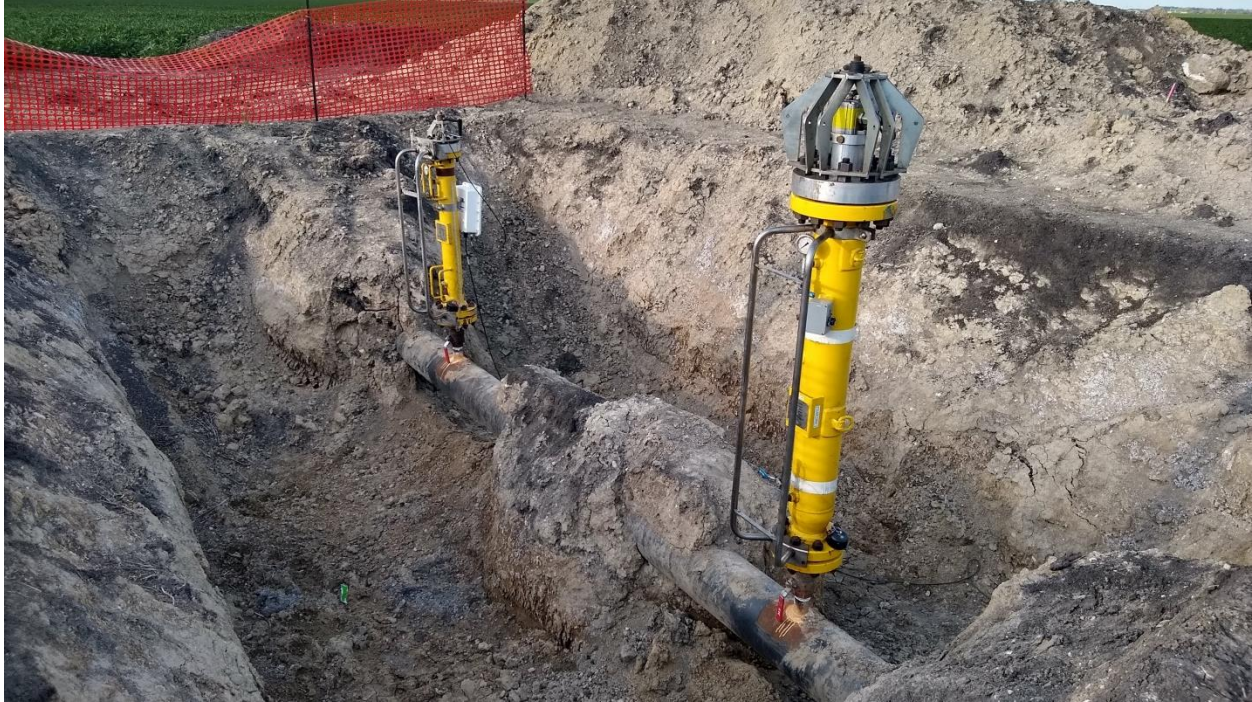
Since Pipe Explorer robots are battery powered, their initial inspection range is limited by the range capacity of the batteries on the unit. In an effort to extend the range of the Pipe Explorer fleet beyond this initial run, Intero implements a proprietary in-line charging (ILC) system which, in effect, adds “refueling” stations for the robot along the pipeline. Since these ILC points are smaller openings and require lighter fittings, the number of more costly size-on-size hot tap fittings can be reduced and the overall inspection time can be reduced from having to exit the line every time the batteries need recharging. In total, nine inline charging sites were utilized during the Brandon lateral inspection. An example of an ILC site is shown in Figure 5.

Figure 5: In-line Charging Site on 10 inch Pipeline

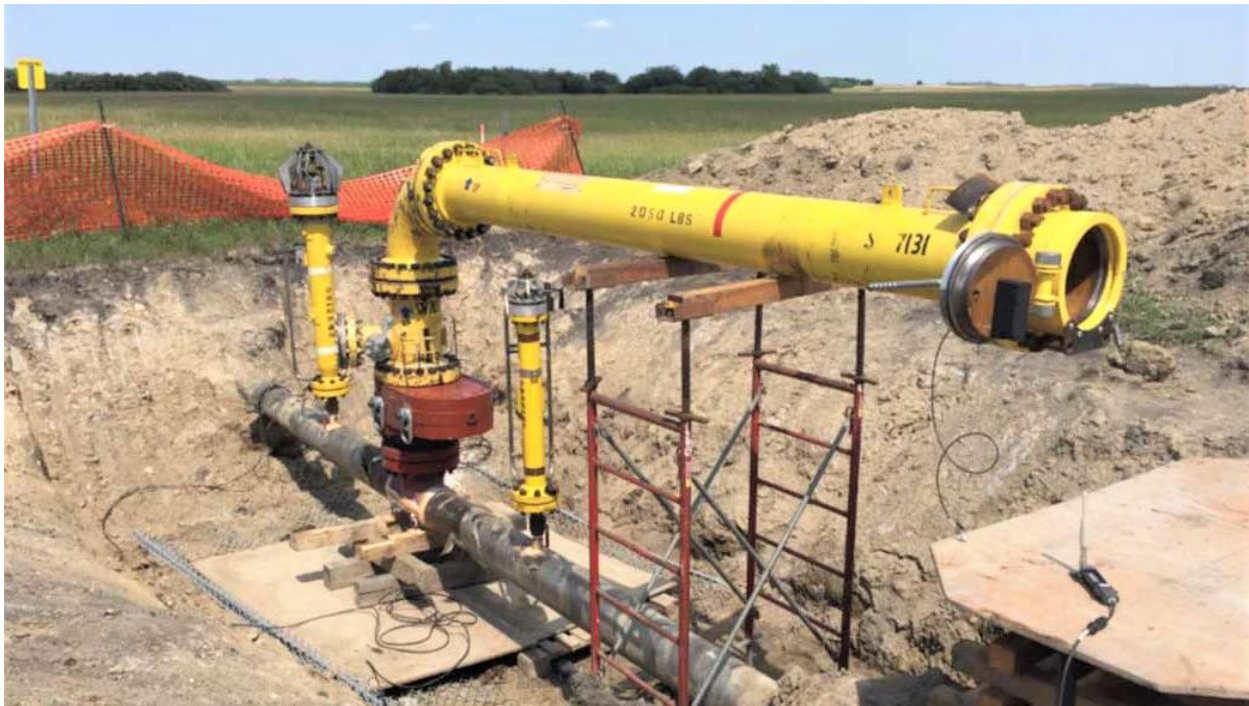
By utilizing this specialized in-line charging technology, pipeline operators are able to execute longer robotic inspections than would otherwise be possible. In the case of the Brandon lateral, the pipeline operator was able to leverage Intero's ILC such that the larger launch system, outlined in Figure 6, would be minimized to four locations on the line, resulting in reduced capital expenditure and a total onsite time of only nine days.

Figure 6: Intero's Launch System for Pipe Explorer 10/14
