## PIGGING IN THE ARCTIC CIRCLE

Anthony Lowery, Baker Hughes, UK  
Richard Sharvin, Baker Hughes, Netherlands

### Abstract

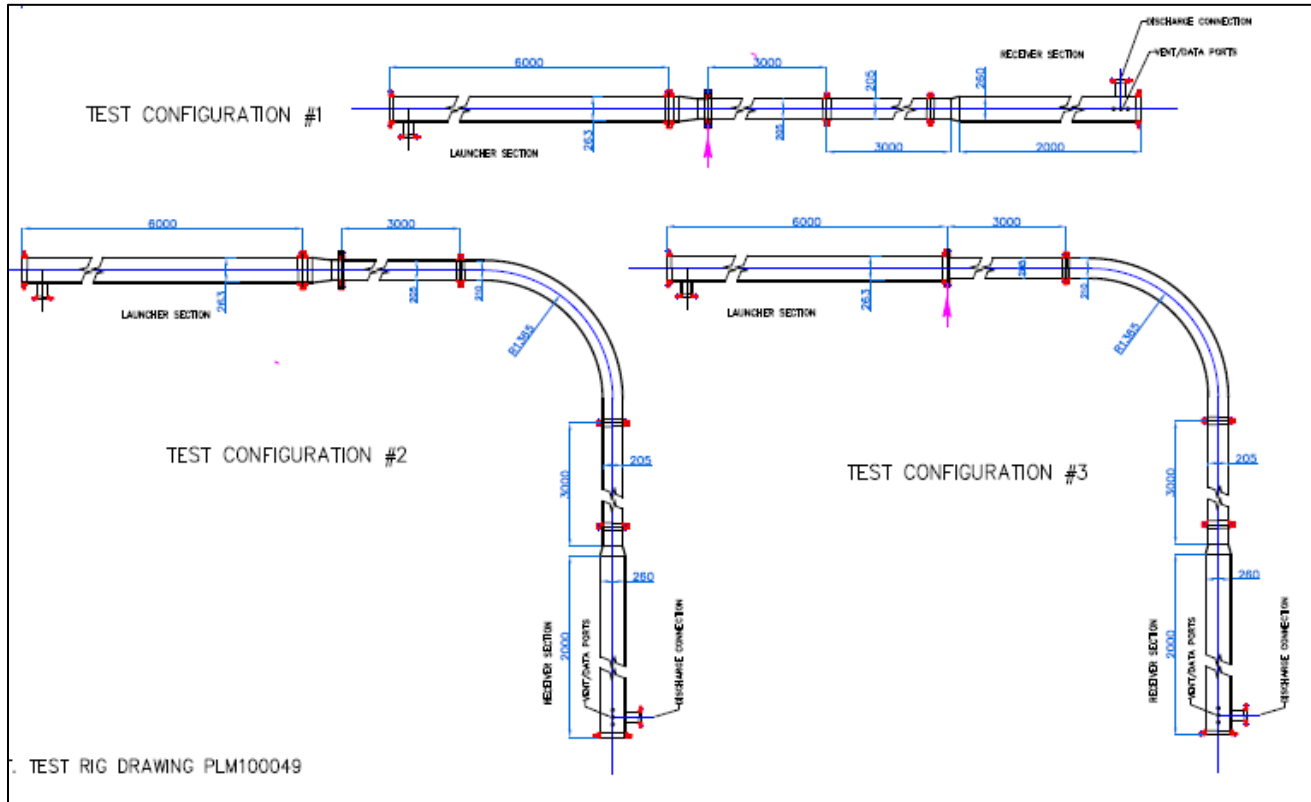
**Figure 7 - Test Rig Configurations**

The testing rig below incorporated restrictions replicating the limits of the MFL inspection vehicle's passing capability, namely 205mm ID in straight pipe and 210mm ID in a 5D bend. Baker Hughes tested below the known feature in the line to provide an additional level of contingency in the operation and also requested a 263mm to 205mm ID taper transition to be included in the rig. However, to determine if the MFL inspection vehicle could pass the 'worst case' transition, Baker Hughes agreed to a final test to determine if the MFL inspection vehicle could pass a fully circumferential step of 29mm. This had never been tested previously.

The test provided a flanged lead in spool (see figure 7) as part of the test rig arrangement with an ID of 263mm. This closely replicated the PLR (actual ID 260.3mm) into which the MFL inspection vehicle would be loaded before being lowered subsea and connected to the pipeline during the infield operation.

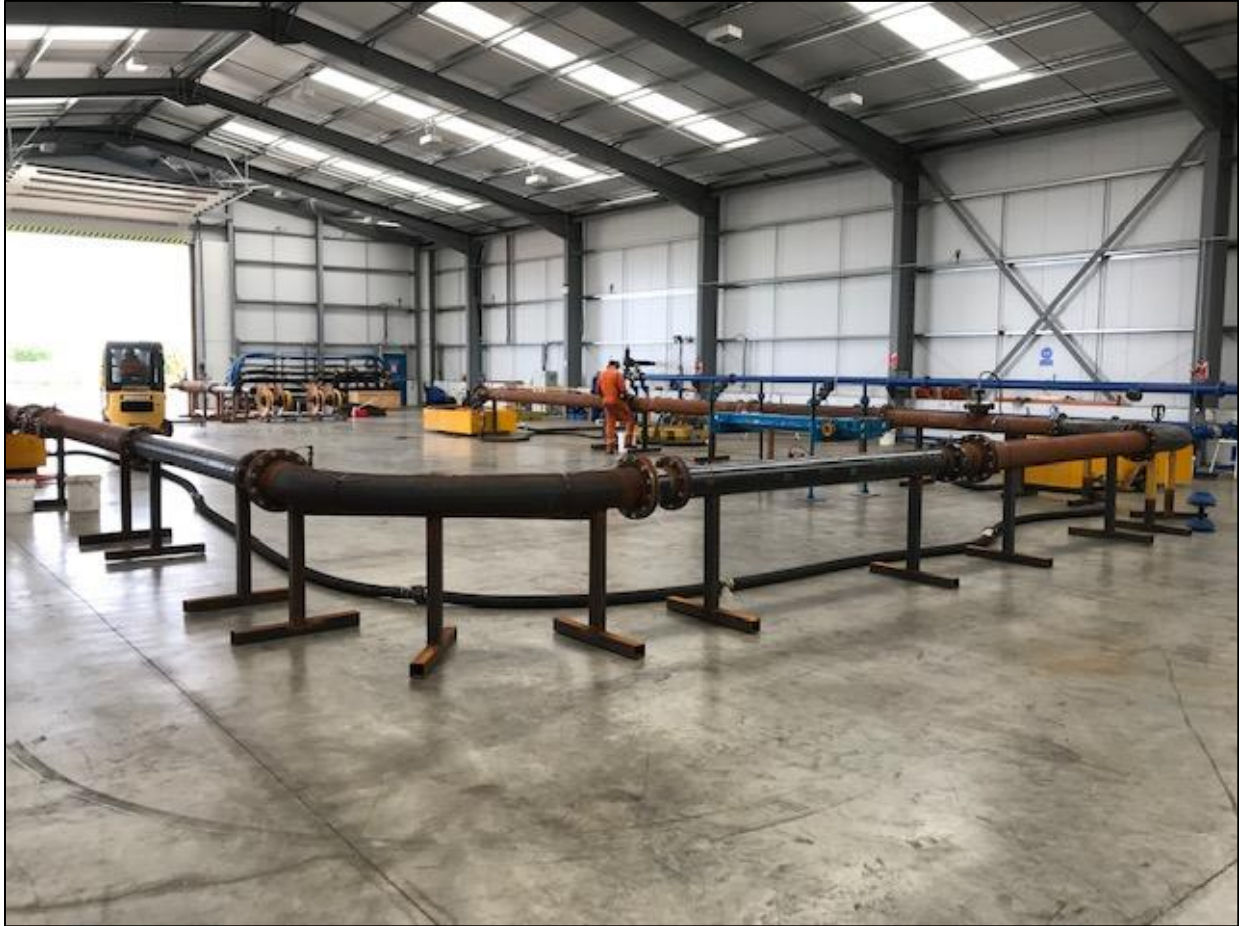
**Figure 10 - Test rig for second 'live' test**

The modified bristle rings allowed for magnetisation and saturation of the test spool with machined defects which were witnessed in the data recorded. All modifications also successfully negotiated the reduced bore sections of the test rig. Analysis of the data recorded determined that the inspection vehicle functioned correctly, with detection and sizing specification confirmed when compared with the defect test spool.

This testing proved successful resulting in various modifications, not least the addition of the Extra Drive Unit. It was modified to increase to 25mm spacers, ensuring the sealing of the cup and centralisation of the MV in the 263mm ID pipe, allowing for full magnetisation.
