THE CHALLENGE OF INSPECTING PIPELINES WITH 'UNKNOWNNS'

PPSA Seminar, Tuesday 17th November 2020

GEERT BONTEKOE, DANNY MOLYNEUX
QUEST INTEGRITY

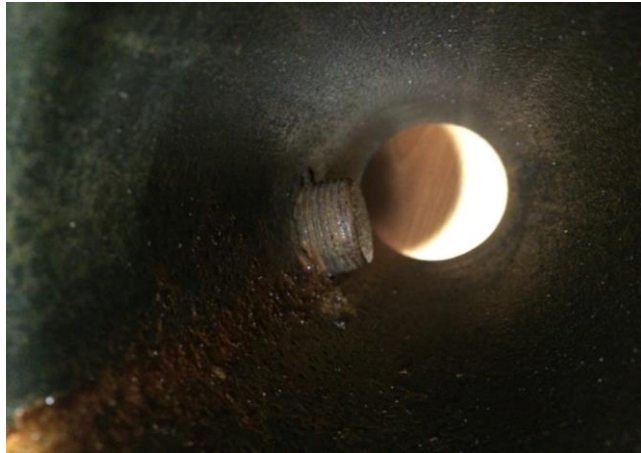
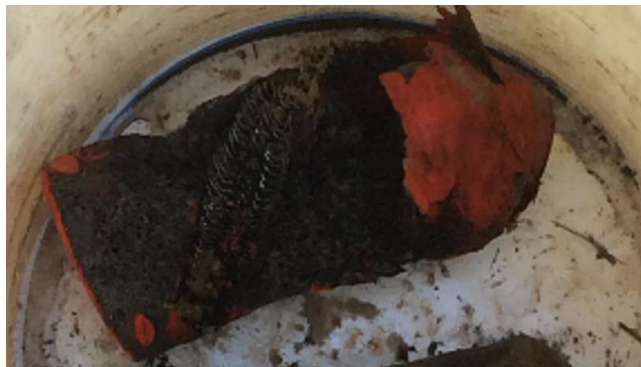
- Forgotten thermocouple
 - Plug placed in the line
- ‘Unknowns’ caused by the loss of operational knowledge or records.

The 3/4” plug on the left and the Thermo couple caused damage to the cleaning pigs

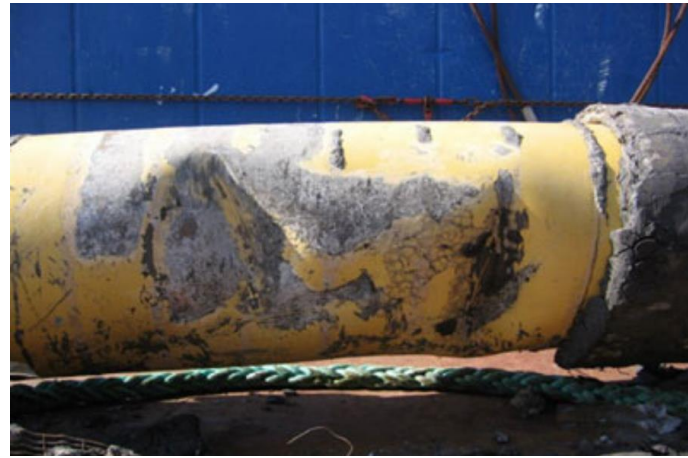
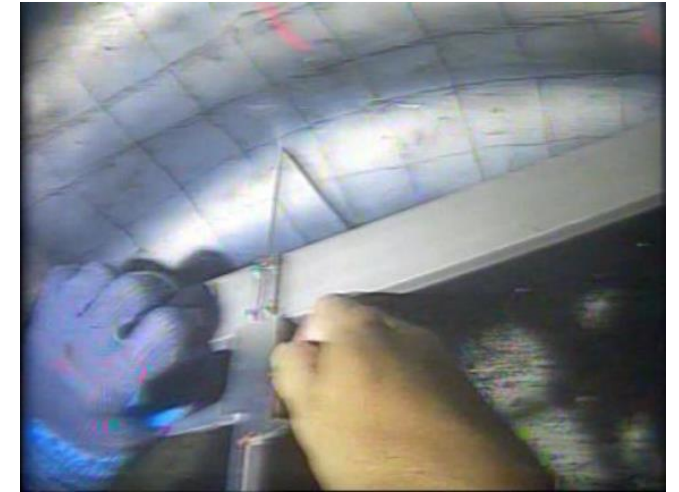
10% dent caused by a ripper on a shallow gas pipeline

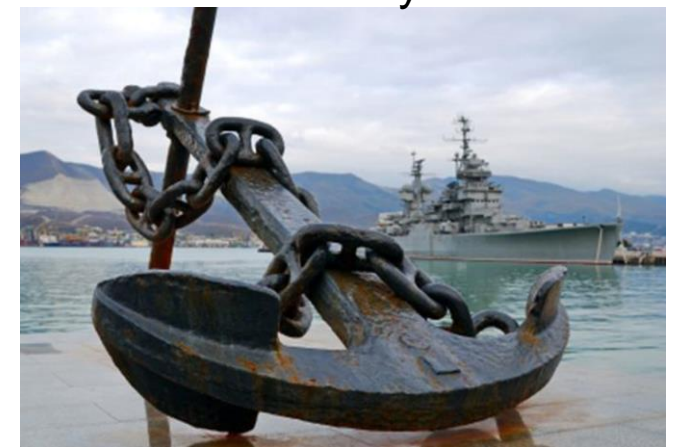
30% dent caused by an anchor

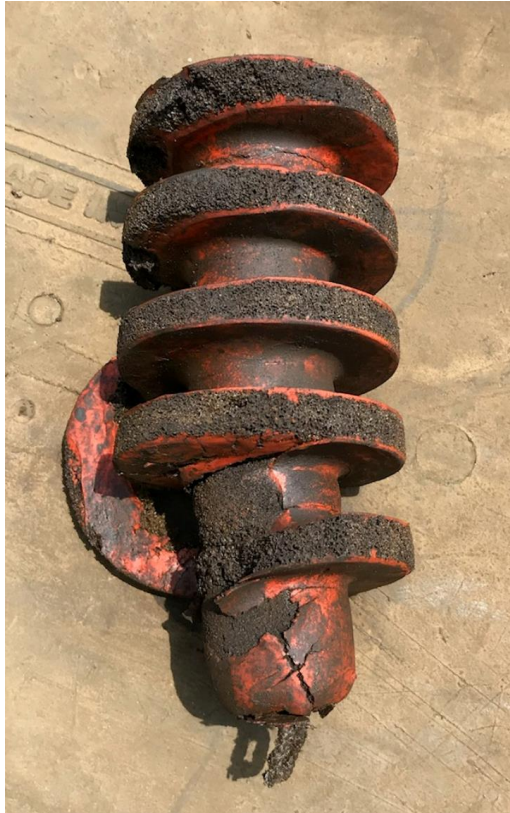
Damaged cleaning pigs or unexpected pressure increases can be a first indication that there is an unknown

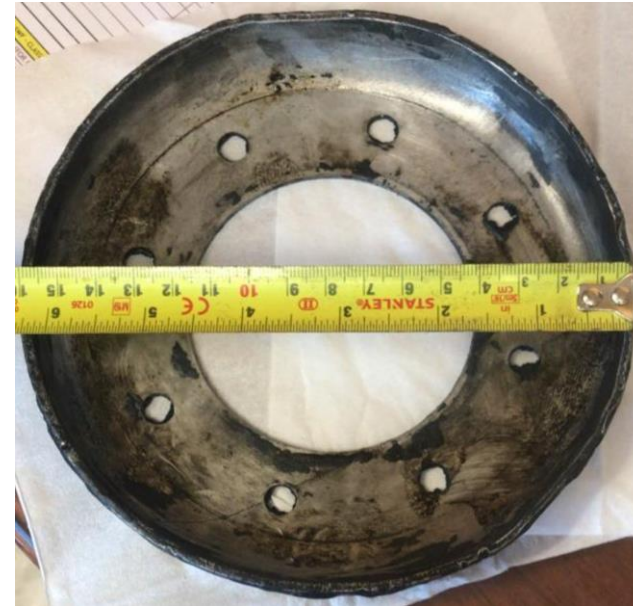
Sending a gauge pig through the line can be the next step

Gauge pig indications are not that reliable, don't tell us geometry or location

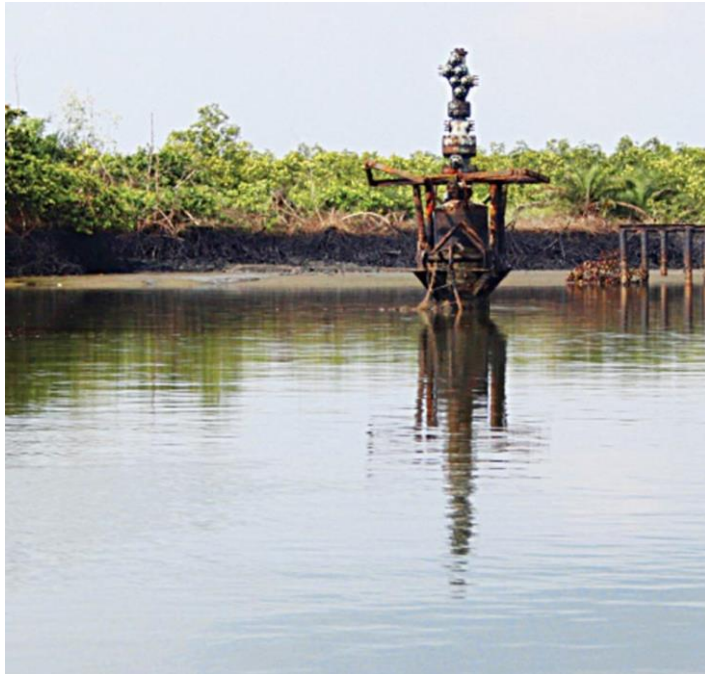
Operationally challenging area
Potential for reduction to 8” under the
mud line.

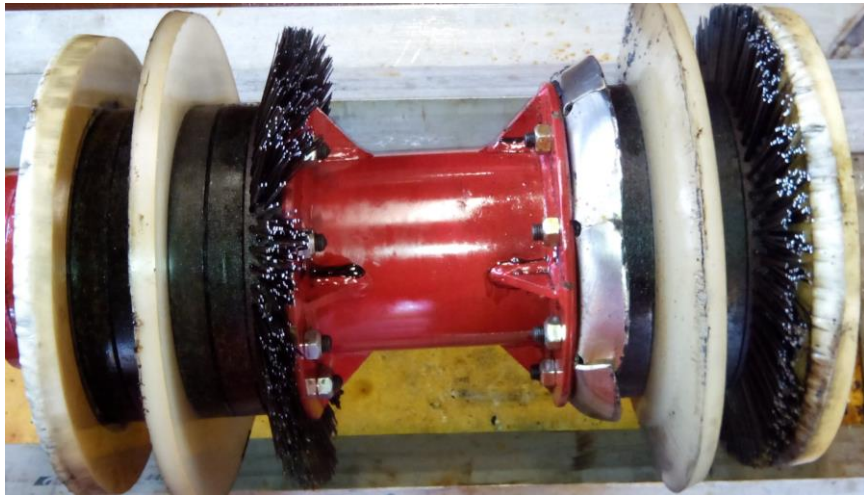
- Subsea line, between 2 platforms
- Pipeline ID = 311.14 mm
- Gauge plate OD = 305 mm
- Gap between Gauge plate and pipe wall = 3mm

Steel body BiDi Mandrel gauge pig with brushes

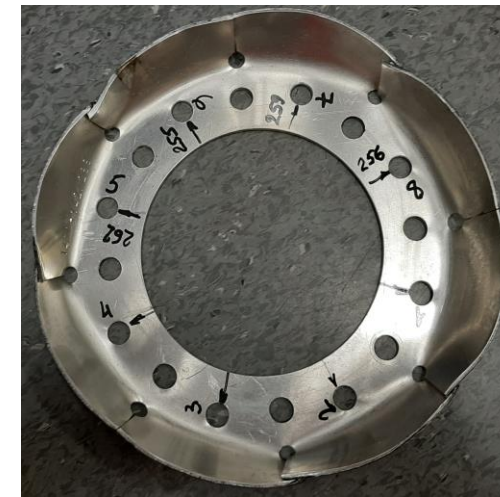
- Gauge plate indicated a reduction in bore to 255mm
- ILI contractor did not attempt to inspect the pipeline
- Client suspected a reduced bore feature
- Drawings did not indicate a reduction in ID

Cup shaped damage could be associated with a 360° reduction. For example a reduced bore valve
